# **Townsend/Gullatt Farmhouse**

Hollywood, Jackson County, Alabama

National Register Nomination  
Historic Preservation Certification Application

Historic Preservation  
Certification Application

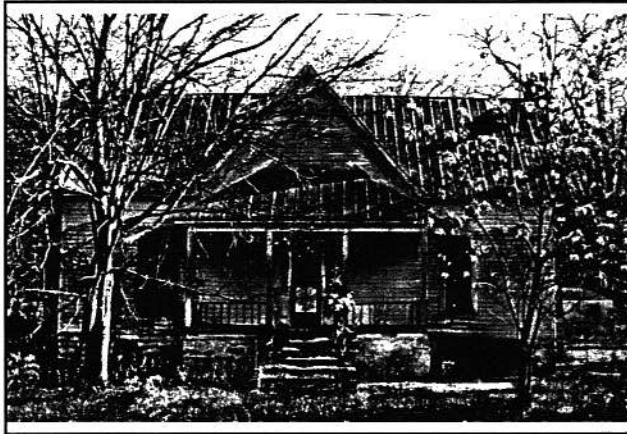
01

### Exterior, West Facade, Facing East

Prior to Rehabilitation: Note existing cross-gable roof with boxed cornice and decorative gable, wood weatherboard siding, hipped porch, central entrance with transom & sidelights, and single 1/1 windows; all significant historic features and fabric will be retained and repaired as needed to match existing adjacent conditions, a new composition shingle roof will be installed to replace the deteriorated V-crimped metal.

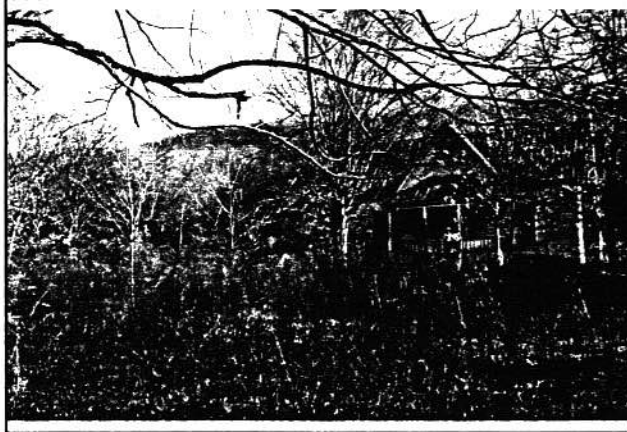
02

### Exterior, Site, Facing Northeast

Prior to Rehabilitation: Note existing cross-gable roof with boxed cornice and decorative gable, wood weatherboard siding, hipped porch, central entrance with transom & sidelights, and single 1/1 windows; all significant historic features and fabric will be retained and repaired as needed to match existing adjacent conditions, a new composition shingle roof will be installed to replace the deteriorated V-crimped metal; site will be re-landscaped in a manner that is compatible with the overall historic character of the site.

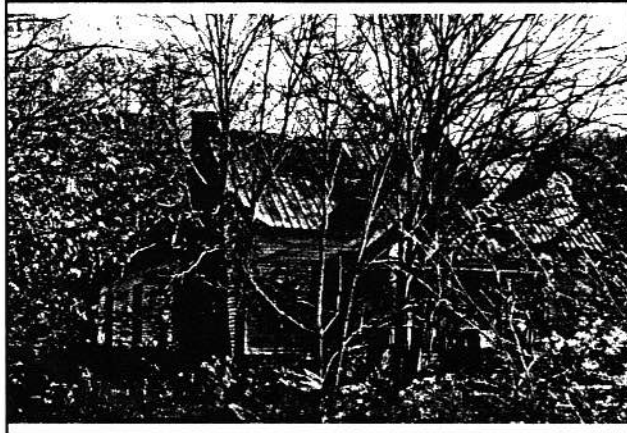
03

### Exterior, Oblique, Facing Southeast

Prior to Rehabilitation: Note existing cross-gable roof with boxed cornice and decorative gable, wood weatherboard siding, hipped porch, central entrance with transom & sidelights, and single 1/1 windows; all significant historic features and fabric will be retained and repaired as needed to match existing adjacent conditions, a new composition shingle roof will be installed to replace the deteriorated V-crimped metal.

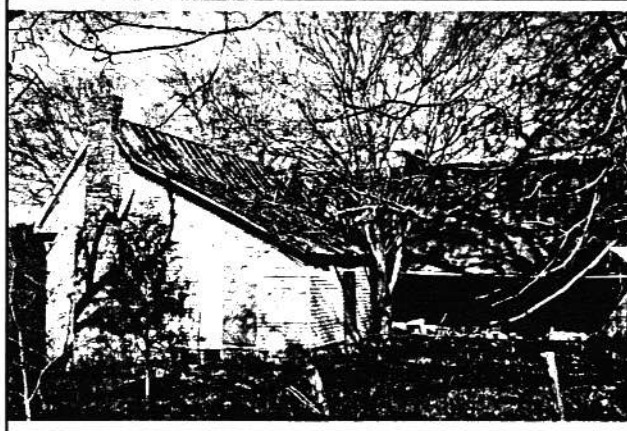
04

### Exterior, Oblique, Facing Northwest

Prior to Rehabilitation: Note existing rear L wing, roof with boxed cornice, wood weatherboard siding, porch structure lost at rear porch, windows covered with plywood; all significant historic features and fabric will be retained and repaired as needed to match existing adjacent conditions, a new composition shingle roof will be installed to replace the deteriorated V-crimped metal; the porch will be reconstructed as an enclosed space per the plans submitted with minimal impact on the overall historic character of the building.

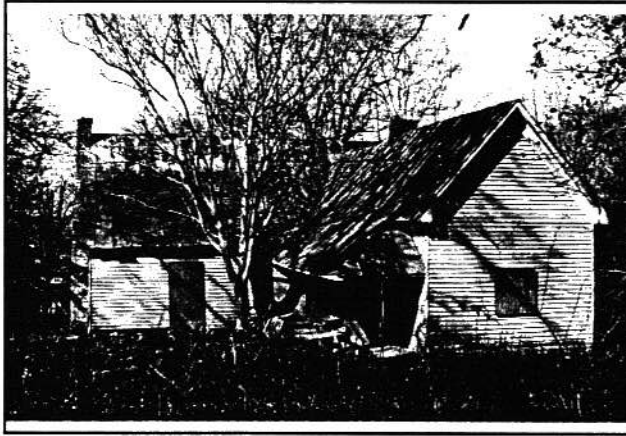
05

Exterior, Oblique, Facing West

Prior to Rehabilitation: Note existing rear L wing, roof with boxed cornice, wood weatherboard siding, porch structure lost at rear porch, windows covered with plywood; all significant historic features and fabric will be retained and repaired as needed to match existing adjacent conditions, a new composition shingle roof will be installed to replace the deteriorated V-crimped metal; the porch will be reconstructed as an enclosed space per the plans submitted with minimal impact on the overall historic character of the building.

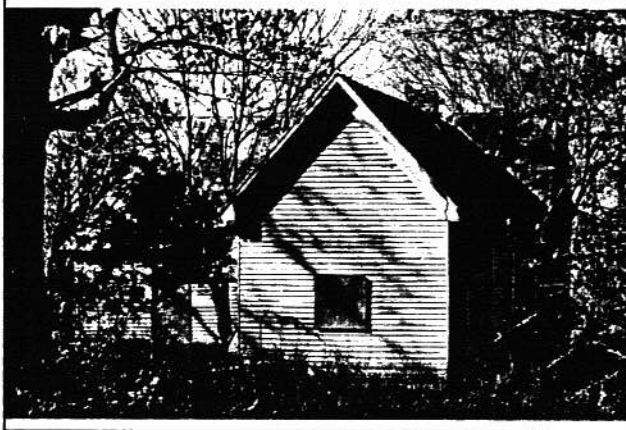
06

Exterior, Oblique, Facing Southwest

Prior to Rehabilitation: Note existing rear L wing, roof with boxed cornice, wood weatherboard siding, porch structure lost at rear porch, windows covered with plywood; all significant historic features and fabric will be retained and repaired as needed to match existing adjacent conditions, a new composition shingle roof will be installed to replace the deteriorated V-crimped metal; the porch will be reconstructed as an enclosed space per the plans submitted with minimal impact on the overall historic character of the building.

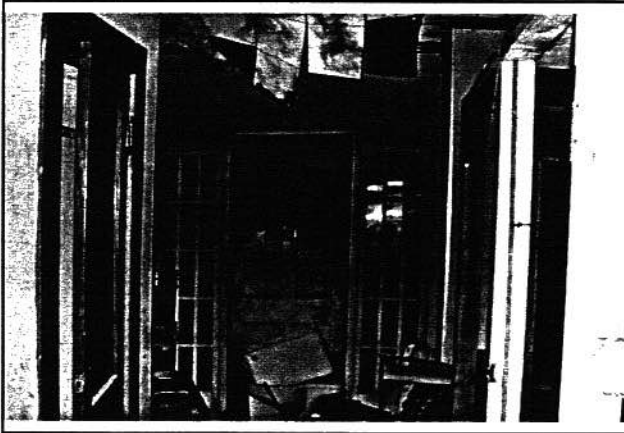
09

### Interior, Rear Hall, Facing East

Prior to Rehabilitation: Secondary rear hallway with replacement sheetrock ceiling and wall finishes, resilient floor coverings, modern closet enclosures and replacement entrance with sidelights (ca. 1960) accessing the former rear porch; all significant historic features and fabric will be retained and repaired as needed to match existing adjacent conditions, new sheetrock finishes will be installed to approximate the visual character of the historic plaster finishes.

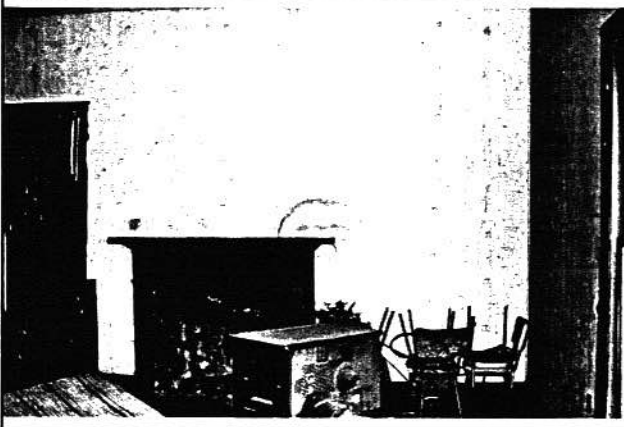
10

### Interior, Southwest Room, Facing Southeast

Prior to Rehabilitation: Room retains its historic mantelpiece and trim; replacement sheetrock ceiling and wall finishes and resilient floor coverings; all significant historic features and fabric will be retained and repaired as needed to match existing adjacent conditions, new sheetrock finishes will be installed to approximate the visual character of the historic plaster finishes.

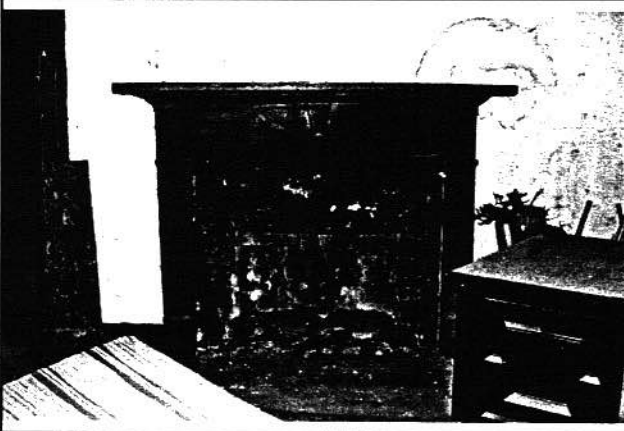
11

### Interior, Southwest Room, Detail of Mantel

Prior to Rehabilitation: Room retains its historic mantelpiece and trim, wood flooring; replacement sheetrock ceiling and wall finishes; all significant historic features and fabric will be retained and repaired as needed to match existing adjacent conditions, new sheetrock finishes will be installed to approximate the visual character of the historic plaster finishes.

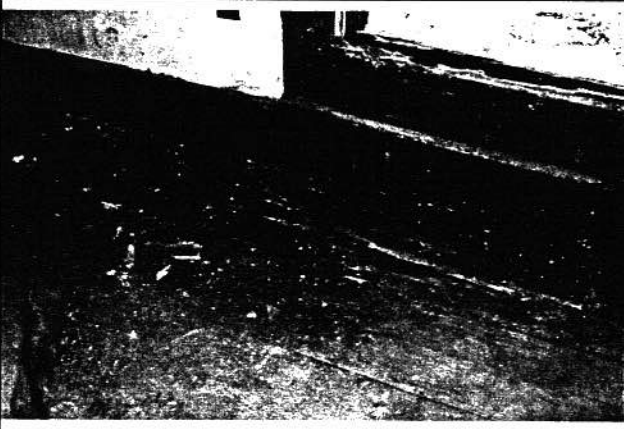
12

### Interior, Southwest Room, Detail of Floor

Prior to Rehabilitation: Room retains its historic mantelpiece and trim, wood flooring; replacement sheetrock ceiling and wall finishes; all significant historic features and fabric will be retained and repaired as needed to match existing adjacent conditions, new sheetrock finishes will be installed to approximate the visual character of the historic plaster finishes; deteriorated flooring will be repaired as needed.

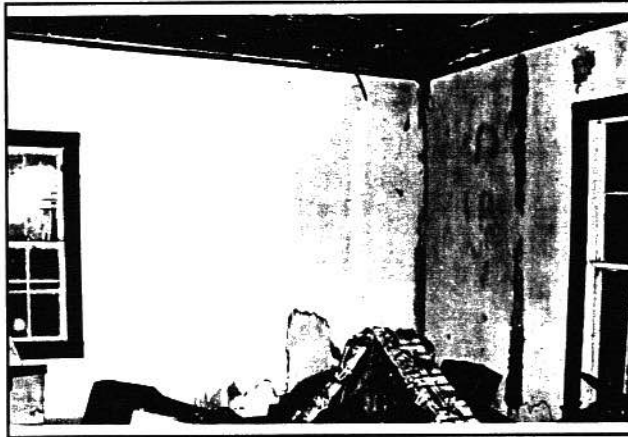
13

### Interior, Southeast Room, Facing Southeast

Prior to Rehabilitation: Deteriorated ceiling, wall and floor due to roof leak; replacement sheetrock ceiling and wall finishes; all significant historic features and fabric will be retained and repaired as needed to match existing adjacent conditions, new sheetrock finishes will be installed to approximate the visual character of the historic plaster finishes.

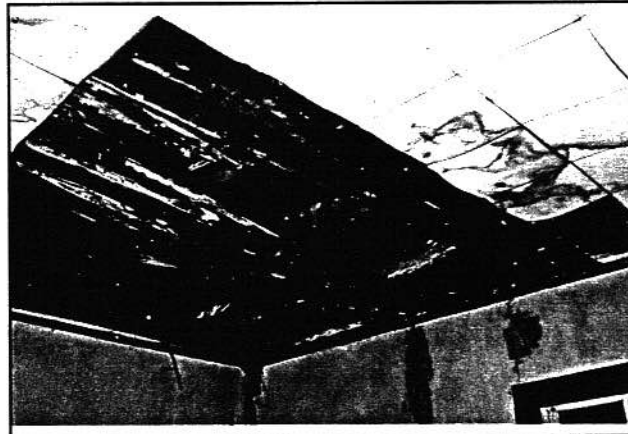
14

### Interior, Southeast Room, Detail of Ceiling

Prior to Rehabilitation: Deteriorated ceiling, wall and floor due to roof leak; replacement sheetrock ceiling and wall finishes; all significant historic features and fabric will be retained and repaired as needed to match existing adjacent conditions, new sheetrock finishes will be installed to approximate the visual character of the historic plaster finishes.

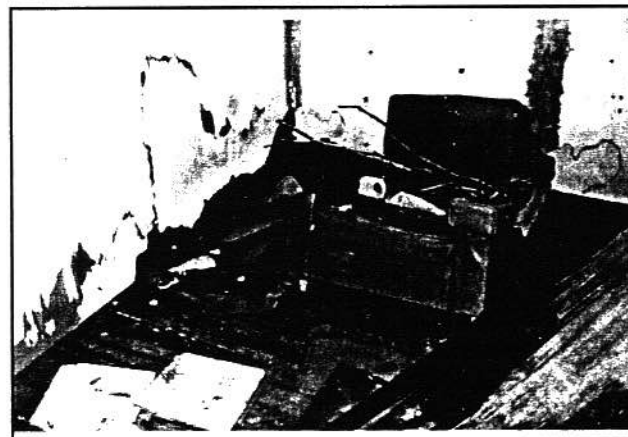
15

### Interior, Southeast Room, Detail

Prior to Rehabilitation: Deteriorated ceiling, wall and floor due to roof leak; replacement sheetrock ceiling and wall finishes; all significant historic features and fabric will be retained and repaired as needed to match existing adjacent conditions, new sheetrock finishes will be installed to approximate the visual character of the historic plaster finishes.

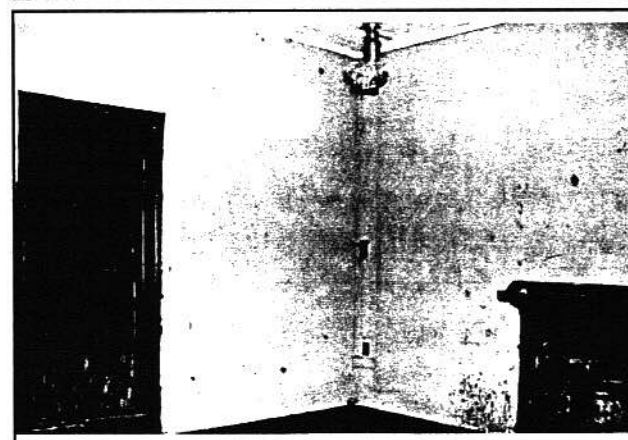
16

### Interior, Northwest Room, Facing Northwest

Prior to Rehabilitation: Room retains its historic mantelpiece and trim; replacement sheetrock ceiling and wall finishes, replacement resilient flooring; all significant historic features and fabric will be retained and repaired as needed to match existing adjacent conditions, new sheetrock finishes will be installed to approximate the visual character of the historic plaster finishes; flooring will be re-exposed and repaired if possible, otherwise new resilient flooring will be installed.

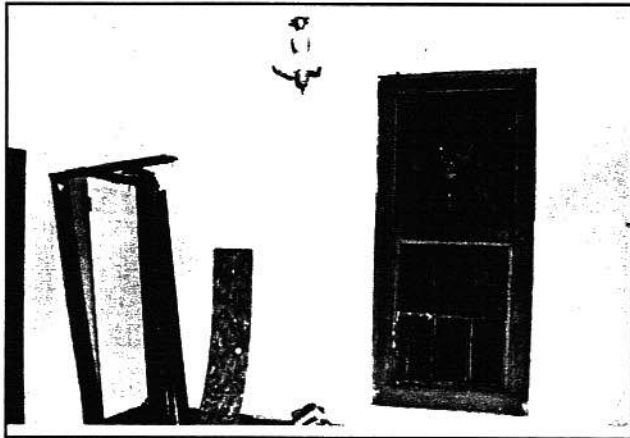
18

Interior, Northeast Room, Facing Northwest

Prior to Rehabilitation: Room retains its historic trim; replacement sheetrock ceiling and wall finishes, replacement resilient flooring; all significant historic features and fabric will be retained and repaired as needed to match existing adjacent conditions, new sheetrock finishes will be installed to approximate the visual character of the historic plaster finishes; this room will be converted for bathroom and closet space per the plans submitted with minimal loss of significant historic fabric.

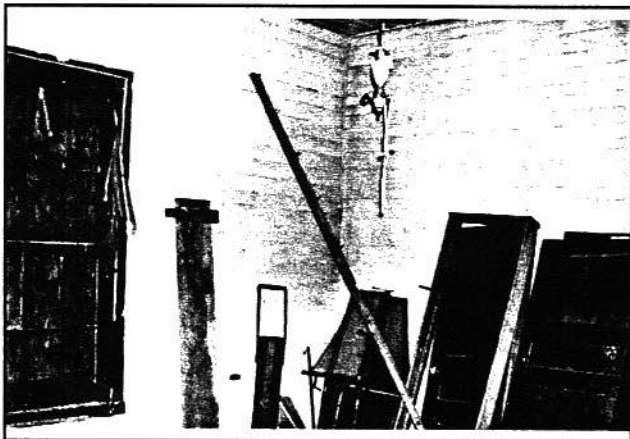
19

Interior, Rear Wing, West Room, Fac. Northeast

Prior to Rehabilitation: Room retains its historic trim, mantelpiece and board ceiling and wall finishes; replacement resilient flooring; all significant historic features and fabric will be retained and repaired as needed to match existing adjacent conditions, wood ceiling and wall finishes will be retained and repainted; flooring will be re-exposed and repaired if possible, otherwise carpeting will be installed.

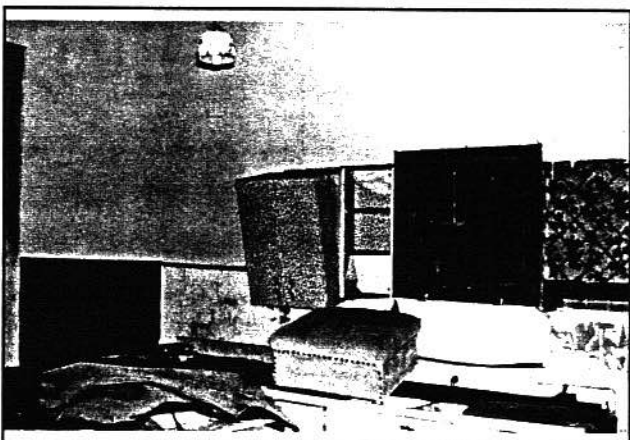
20

Interior, Rear Wing, Kitchen, Fac. Northeast

Prior to Rehabilitation: Room retains its historic trim; replacement sheetrock ceiling and wall finishes, replacement resilient flooring; all significant historic features and fabric will be retained and repaired as needed to match existing adjacent conditions, new sheetrock finishes will be installed to approximate the visual character of the historic plaster finishes; flooring will be re-exposed and repaired if possible, otherwise carpeting will be installed.

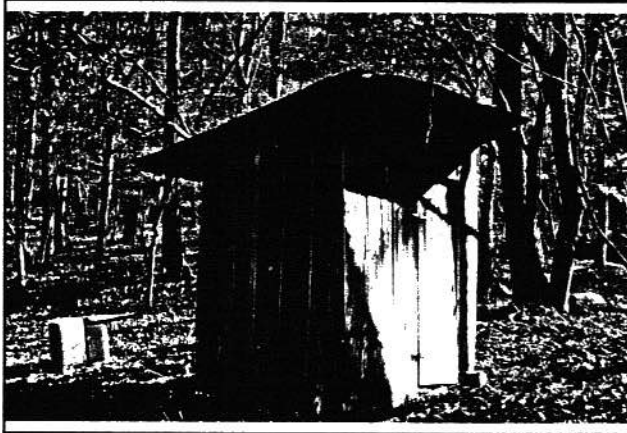
**21**

**Site, Privy, Facing East**

Prior to Rehabilitation: The privy will be retained. No work is planned during this project.

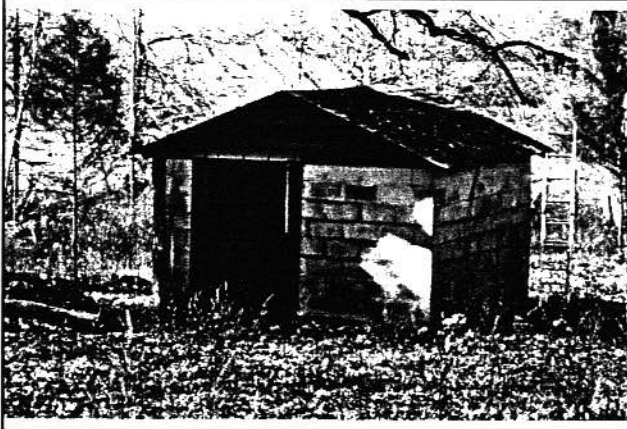
**22**

**Site, Well House, Facing Southwest**

Prior to Rehabilitation: The noncontributing well house will be retained and repaired as needed.

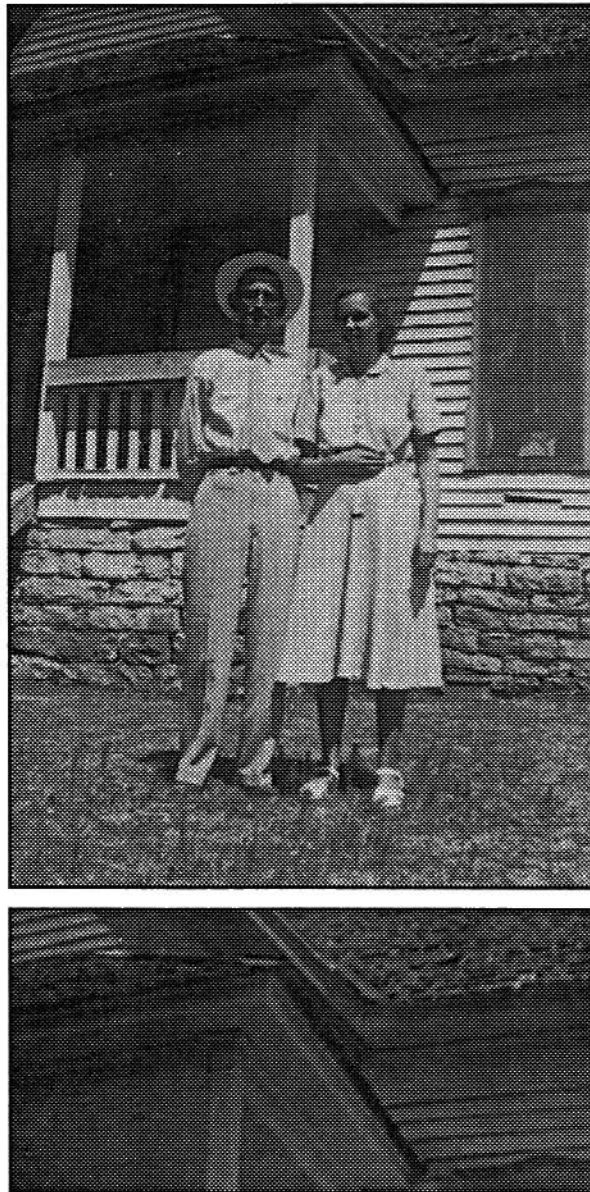
**Photo #1:** View of the Townsend/Gullatt Farmhouse taken circa 1949 Note that the house retained its historic wood shingle roof at that time. The present owner, Betty Gullat Budding recalls that the metal roofing was applied circa 1960 when the house became vacant. The roofing was installed as a temporary measure to prevent the house from deteriorating.

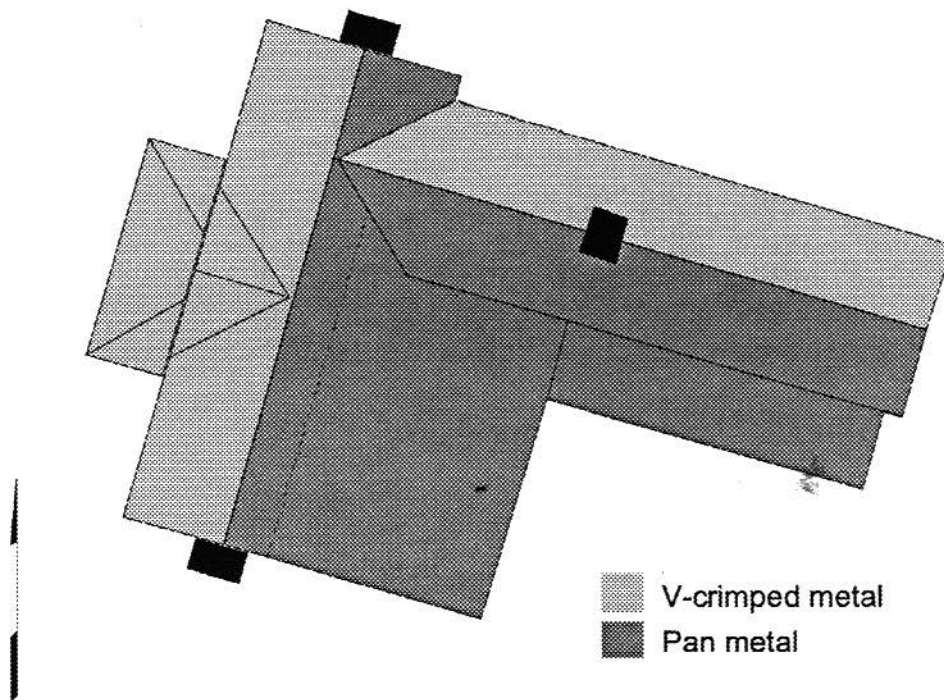
Figure #1: Existing roof material location.

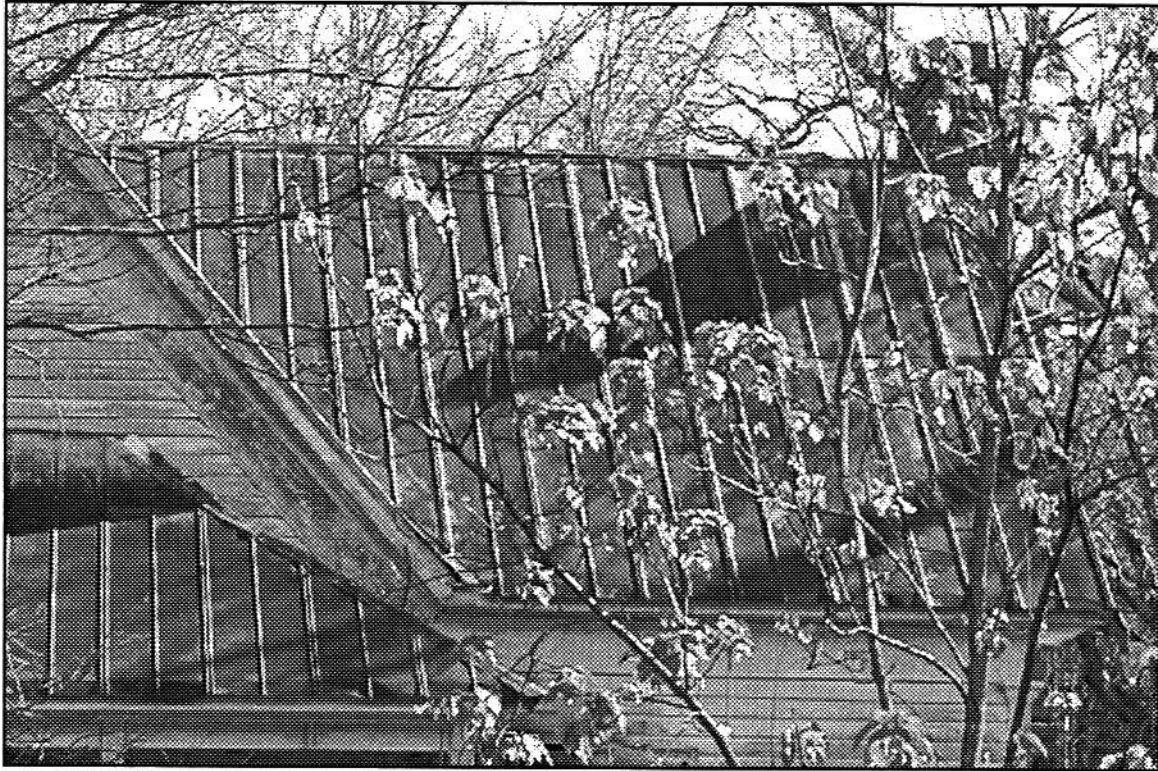
Photo #2: Front slope of roof, note V-crimped metal roofing in fair to poor condition.

The existing non-historic metal roofing will be replaced with composition shingles. The shingles will be visually compatible with the historic character of the house and will restore a weather-tight condition to the roof and prevent further moisture-related deterioration.

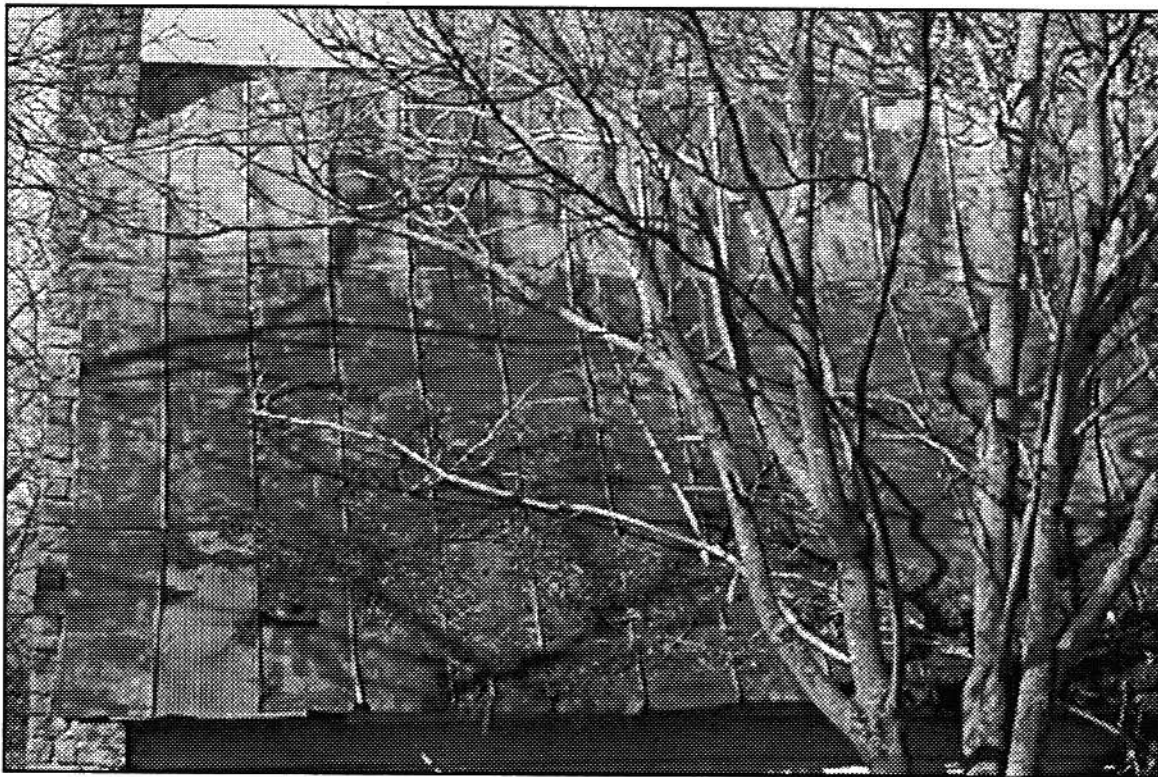
Photo #3: Rear slope of roof, note raised seam metal roof in fair to poor condition.

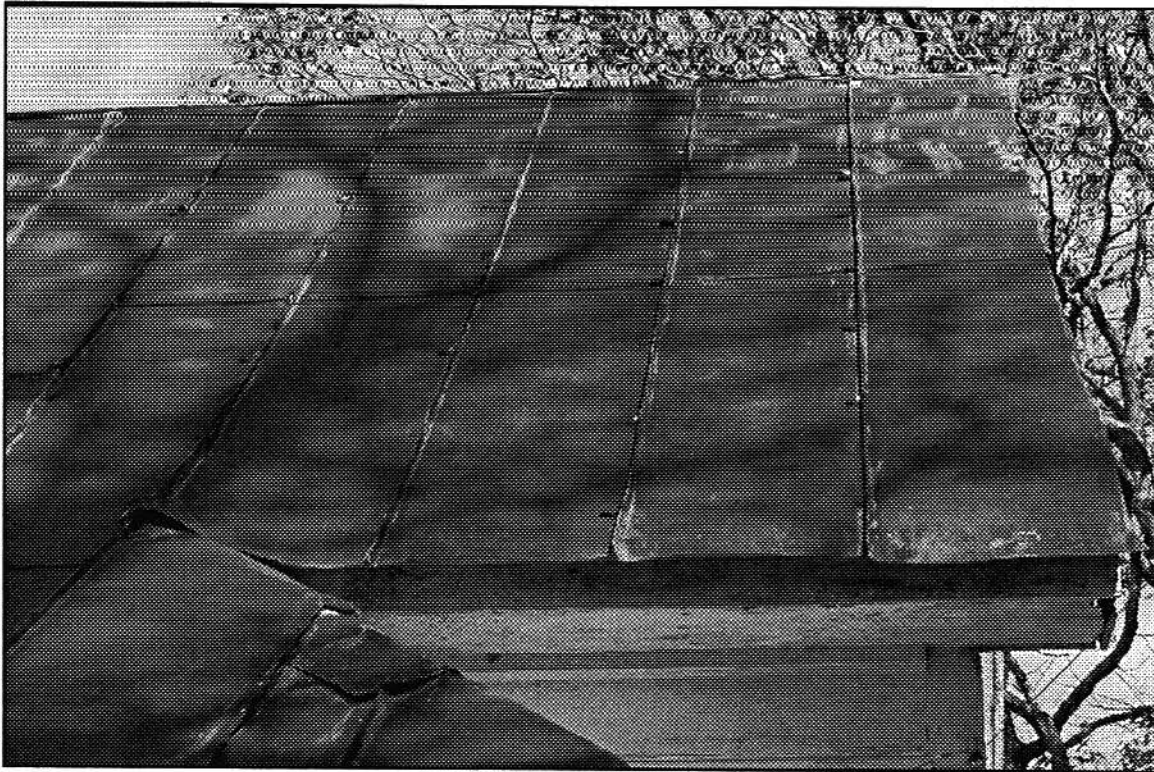
Photo #4: South slope at rear ell, note roof pans interlocked, not crimped and with exposed tabs.

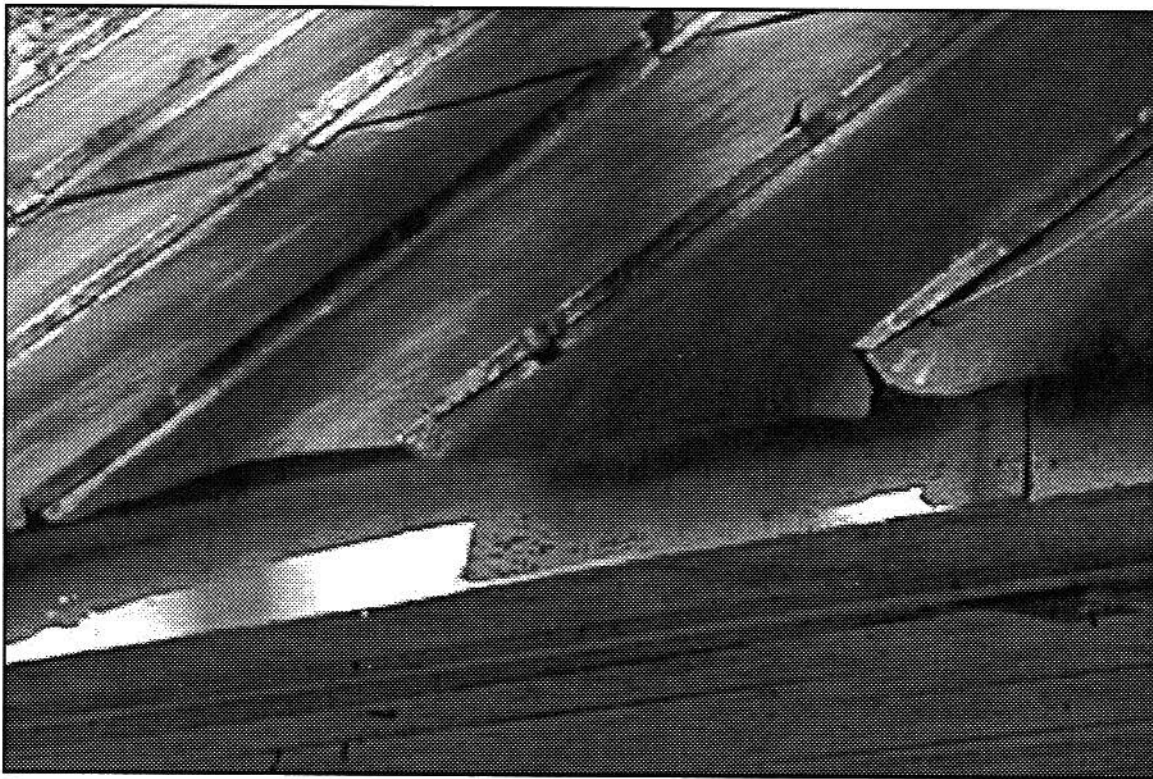
Photo #5: Detail of above, note seams not crimped; deteriorated condition of roofing.

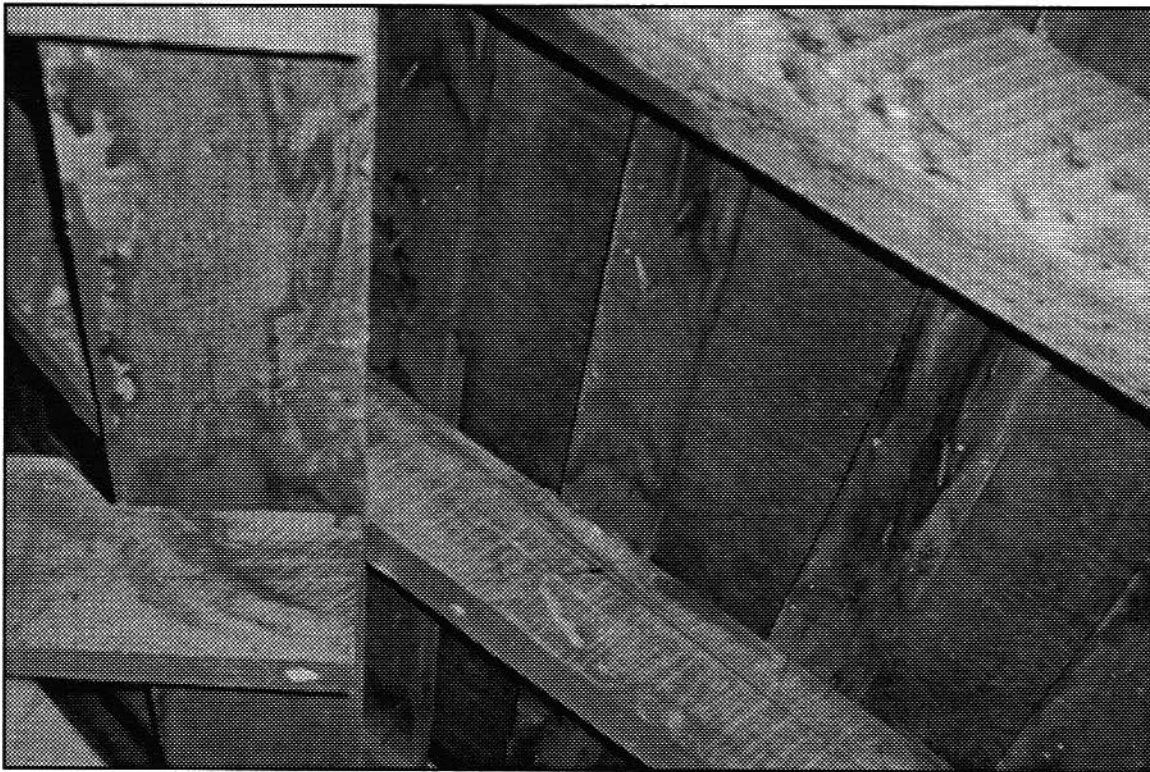
**Photo #6:** Interior at rear ell, note nails from older wood shingles protruding through roof boards.

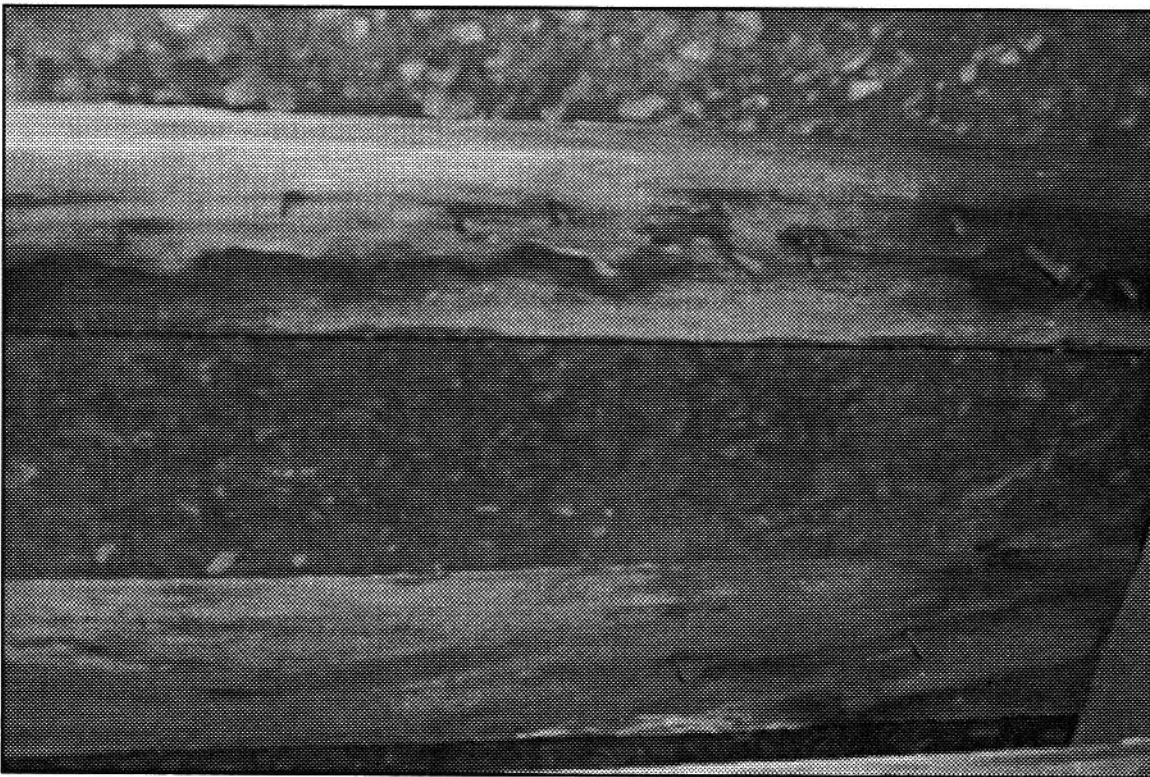
**Photo #6:** Interior at rear ell, note nails from older wood shingles protruding through roof boards.

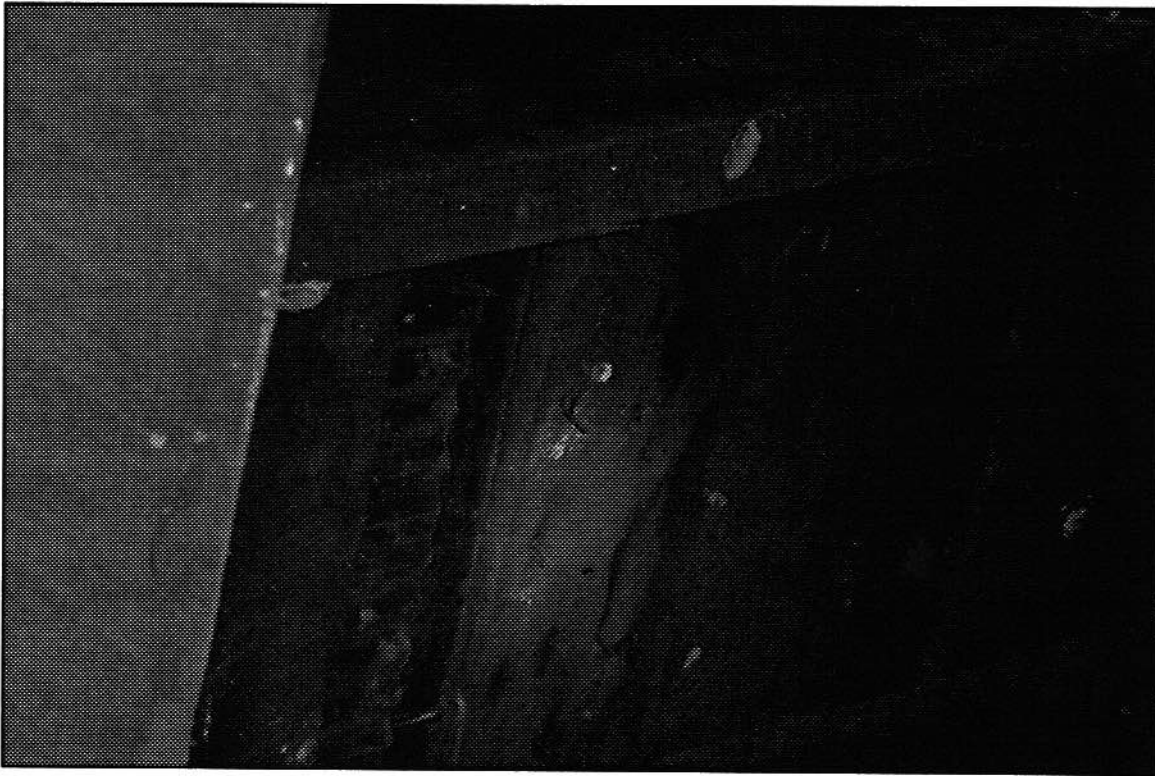
**Photo #8:** Interior at rear ell, note nails from older wood shingles protruding through roof boards.

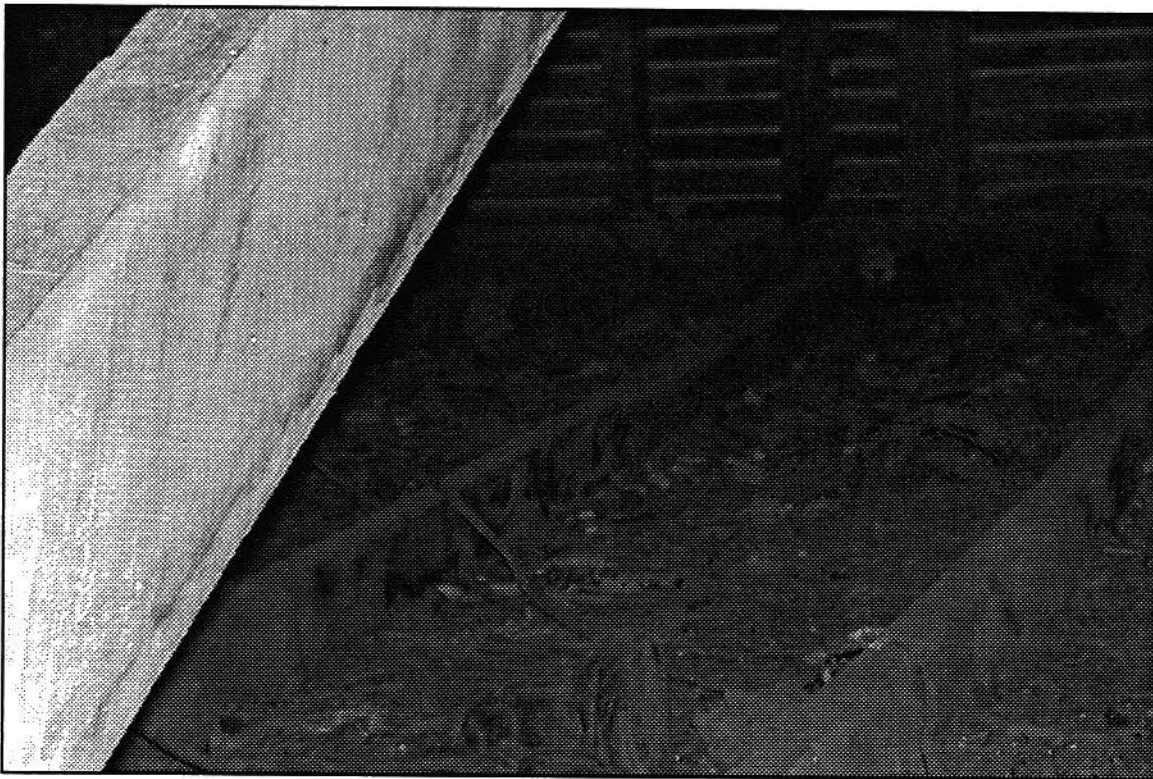
**Photo #9:** Interior at core, note pieces of broken roof shingles found within attic..
